**NATIONAL REGISTER OF HISTORIC PLACES
REGISTRATION FORM**

historic name Compton-Johnson House

other names/site number Wayne Post Office

7. NARRATIVE DESCRIPTION

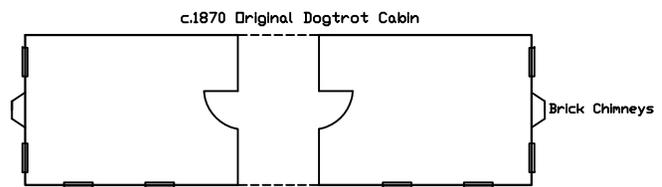
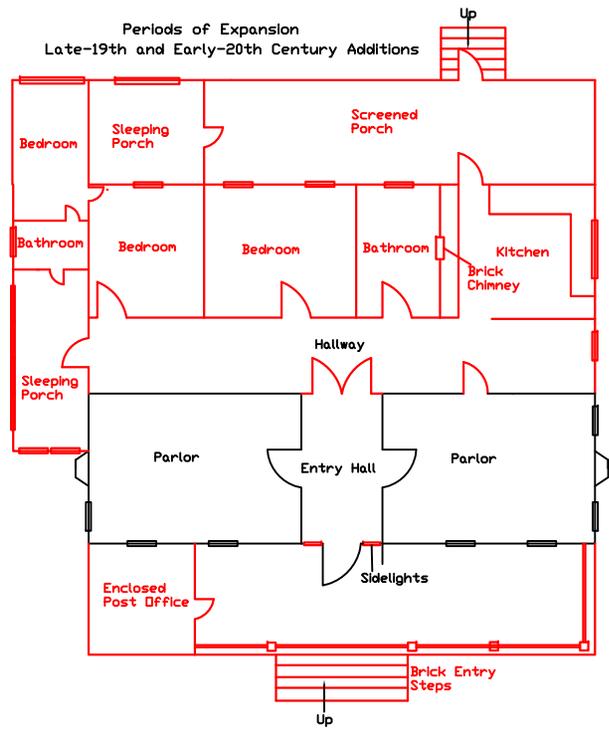
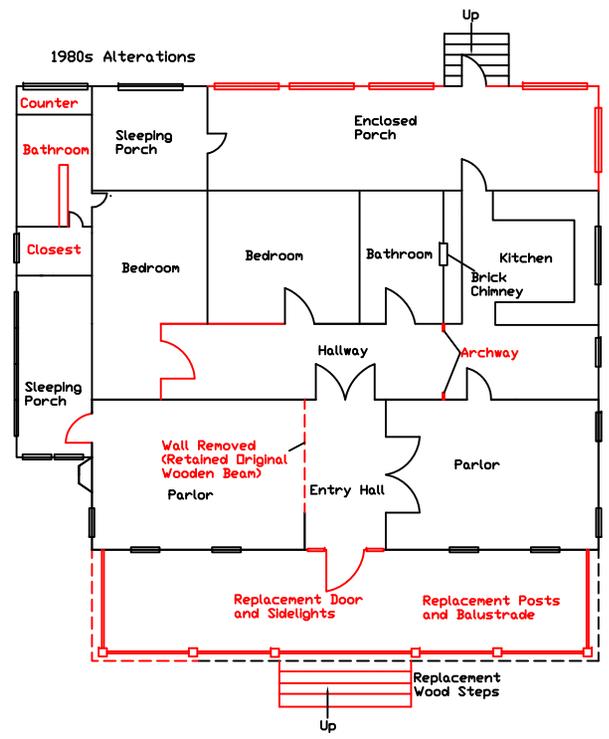
Compton-Johnson House
8825 Highway 43
Dixon's Mills, Marengo County, Alabama
Floorplans

EVOLUTION OF THE COMPTON-JOHNSON HOUSE

In plan, the front portion of the house (to the rear of the porch) conforms to a traditional arrangement of two rooms on either side of a central hall. However, the rear portion of the house departs from this regular arrangement for a more complex plan, thus reflecting the growth of the structure during the late-19th century and early-20th century expansion periods. Detail throughout the house is very modest with little embellishment. Doorframes, window trim, and baseboards are very simple. Doors are typically of a four-panel design. Flooring is typically wood planking of a consistent width.

The original dogtrot structure remains the core of the house. During the 1980s alterations, the door and majority of wall separating the front left parlor and the central hall were removed. However, a large beam of the original dogtrot remains exposed as a reminder of the early form of the original house. Also during the 1980s alterations, a window was removed and replaced with a door leading to a sleeping porch addition. According to Mrs. Drinkard, this door was an early-20th century door located elsewhere in the house. The door features a large stained-glass window. Another significant alteration to the dogtrot structure during the 1980s renovations is the removal of the brick chimney at the east end.

At the north end of the front entry hall, double doors open to reveal the late-19th century additions. The 12-foot ceilings of the original dogtrot structure make way to the 14-foot ceilings of the late-19th century additions. A long hallway runs perpendicular to the central hall of the dogtrot core. This hallway once ran the length of the house; however, was shortened at both ends in the 1980 alterations when the western bedroom was expanded. The kitchen area was separated from the hallway with an arched entry. In addition to the long, full-width hallway, other late-19th century rooms and additions under the principal roof include two bedrooms, a bathroom, and kitchen. The bathroom window is frosted, 2:2 double hung sash. The two windows in the middle bedroom are also 2:2 double-hung sash. The westernmost bedroom features paired 4:4 windows. Windows in both bedrooms and bathroom open to the early-20th century rear additions. A sleeping porch addition and small bedroom were also added during the early-20th century along the west end of the house under a separate shed roof. A doorway leads from the kitchen to the early-20th century rear, porch addition. Initially screened, the 1980s alterations included enclosure of the porch. Another doorway leads from the west end of the rear porch to a second, enclosed sleeping porch associated with the early-20th century additions.
